# LESSONS LEARNED from the SPACE SHUTTLE PROGRAM

Doug Thorpe, Lockheed Space Operations (ret)  
Kennedy Space Center, Florida

John W. Robinson, Boeing (ret.)  
Seal Beach, California

Russel E. Rhodes, NASA (ret.)  
Kennedy Space Center, Florida

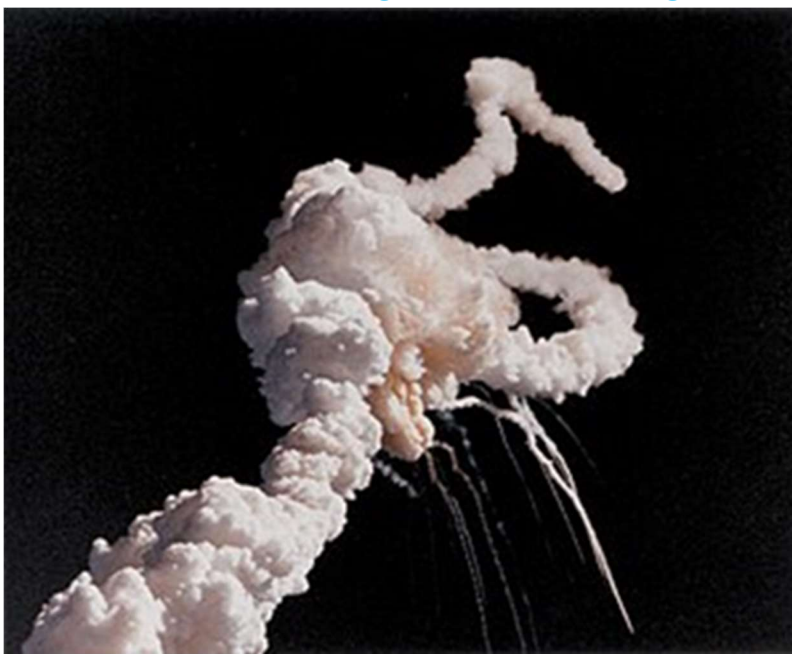
### Space Shuttle Challenger disaster - Image

*Challenger's solid rocket boosters fly uncontrollably after the collapse/breakup of the external tank (ET) separated them from the shuttle stack. The remains of the orbiter and tank leave thin white contrails as they fall toward the ocean and certain death of the crew at water impact.*

The two solid rocket boosters (SRBs), built by Morton Thiokol, provided the majority of thrust at liftoff. They were attached to the external tank, and burned for the first two minutes of flight. The cause of the disaster was the failure of the primary and secondary redundant O-ring seals in the AFT field joint of the shuttle's right hand solid rocket booster (SRB). The record-low temperatures on the morning of the launch had stiffened the rubber O-rings, reducing their ability to seal the joints. The Zinc Chromate Putty had also stiffened and did not follow the joint dynamics allowing hot gas to impinge on the O-rings. Shortly after T-O, the seals were breached, and hot pressurized gas from within the SRB leaked through the joint and over a course of 72 seconds burned through the aft attachment strut connecting the SRB rocket to the external LH2 propellant tank (ET), then through the ET's thin skin LH2 tank. The collapse of the ET's internal structures and the rotation of the SRB that followed, moved the shuttle stack, traveling at a speed of Mach 1.92, into a trajectory that allowed aerodynamic forces to tear the orbiter apart. Both SRBs broke away from the now collapsed and failing ET and continued to fly uncontrollably until the range safety officer destroyed them<sup>7</sup>.

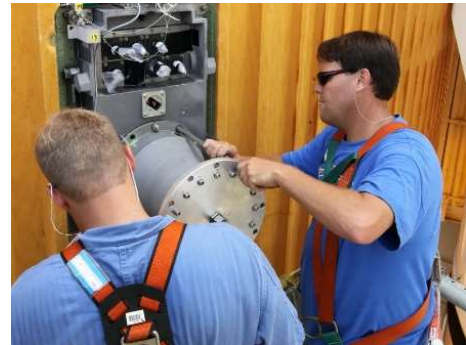
4. **Ground Umbilical Carrier Plate (GUCP):** The GUCP served as a critical interface between ground systems and the ET, connecting the gaseous hydrogen vent line along with purge and instrumentation systems. Derived from earlier Saturn V hardware, it functioned as a T-0 umbilical. Late in the program, the GUCP became increasingly sensitive to installation and alignment during quick disconnect (QD) operations. These issues were largely attributed to design creep and "recertification by similarity," often performed by less experienced engineers without full historical context.

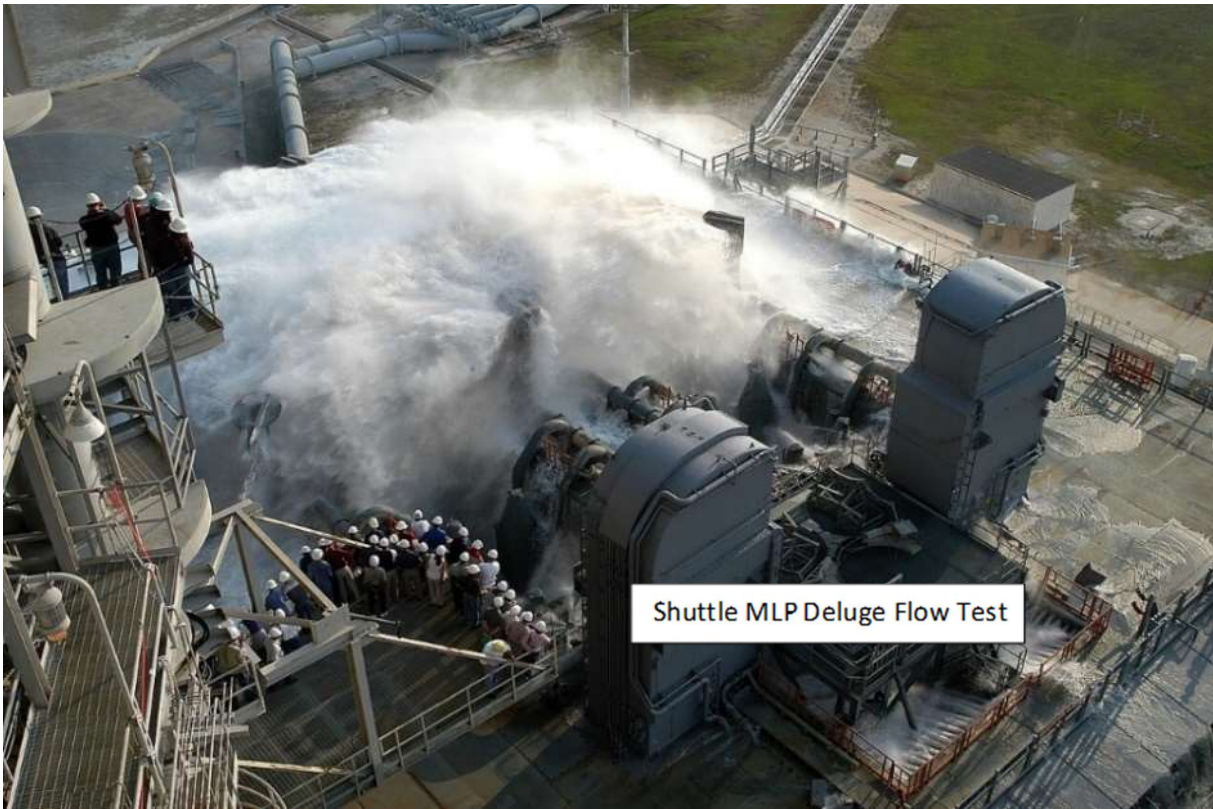
## 7: SOUND SUPPRESSION SYSTEM

The Sound Suppression System (SSS) was designed to mitigate the intense acoustic energy generated by the Space Shuttle's main engines and solid rocket boosters during launch. This system was crucial in protecting the Shuttle, its payloads, and facilities from damage caused by sound waves. The SSS consisted of 6 nozzles, 12 feet high, known as "rainbirds," which released 300,000 US gallons of water in only 41 seconds onto the launch platform and into the SRB/MLP exhaust hole. An additional six water nozzles surrounded each SRB nozzle.

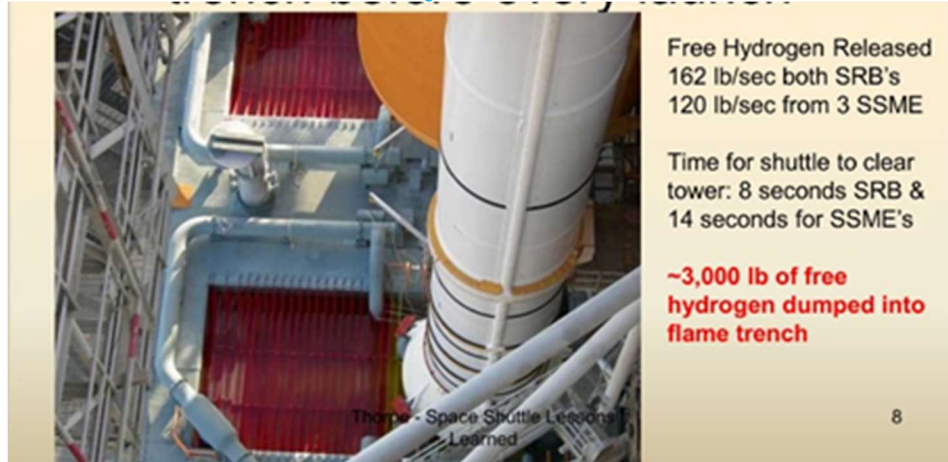
Image: To reduce effects of H<sub>2</sub> detonation on the Orbiter sound suppression water bags were installed in the SRB flame holes before every launch.

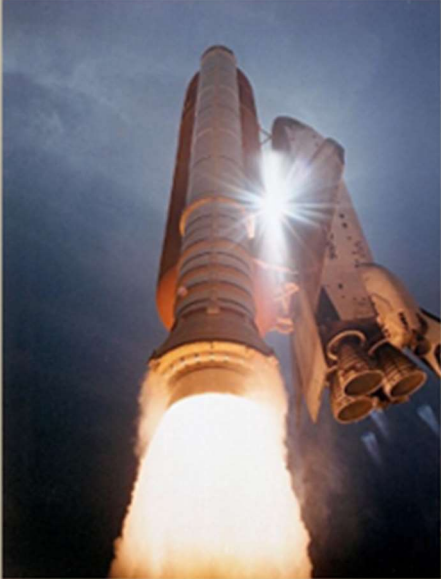
### SSME's were also dumping H<sub>2</sub> into flame trench

- Each SSME's (RS-25 engines) produced 418,000 lb of thrust on flowrate of 1,134.26 lb/sec.
- 6.03:1 oxidizer to fuel ratio
  - 161.3 lb/sec of LH<sub>2</sub>
  - 972.9 lb/sec of LOX
- But stoichiometric for LOX-LH<sub>2</sub> is 8:1, so 972.9 lb/sec of LOX only burns 121.6 lb/sec of LH<sub>2</sub> meaning: **~120 lb/sec of free hydrogen dumped / 3 engines**
